Site Visit Report

Project: Illusion Building 101

Date: 21/03/2024

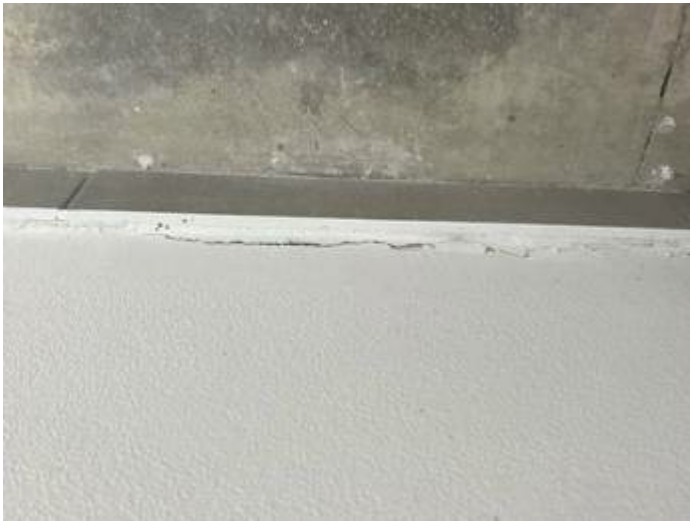
ID:1 **Title: Cracked tile joint**

Comments: Parking

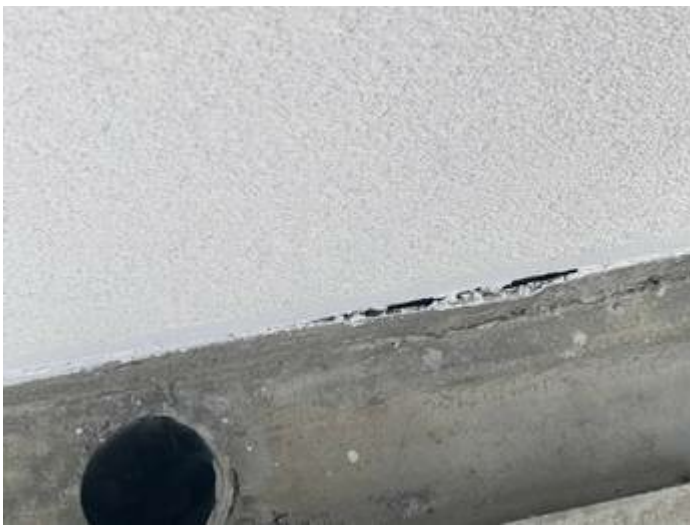
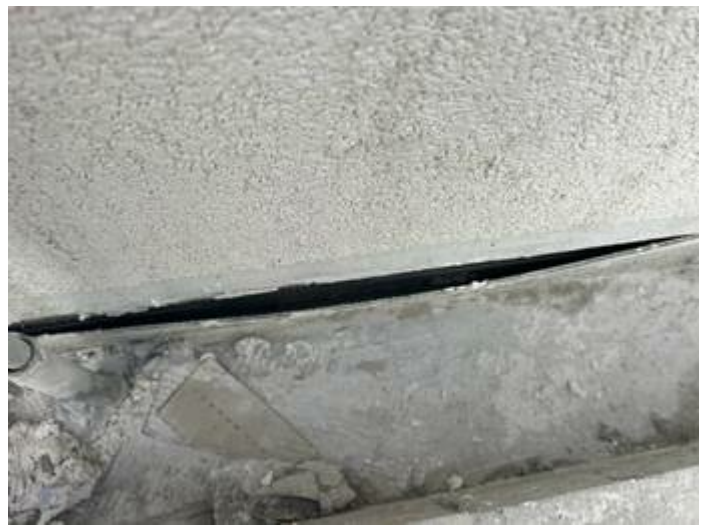
ID:2 Title: Water insulation went of the wall

Comments: Parking
Redo the insulation

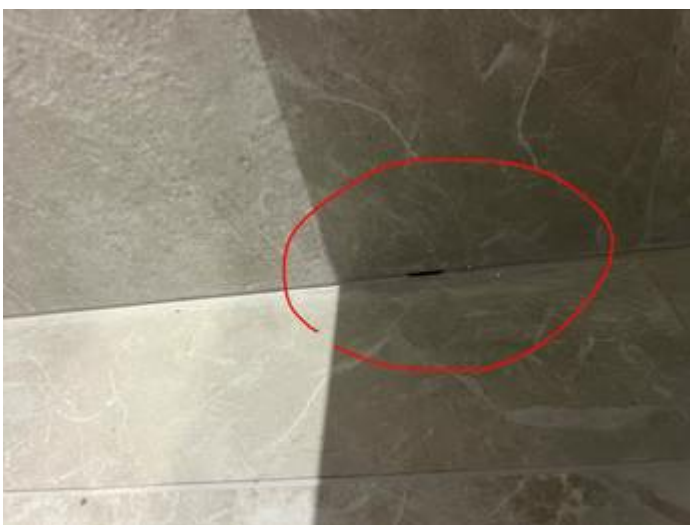
ID:3 Title: Badly done grouting

Comments: Guest toilet

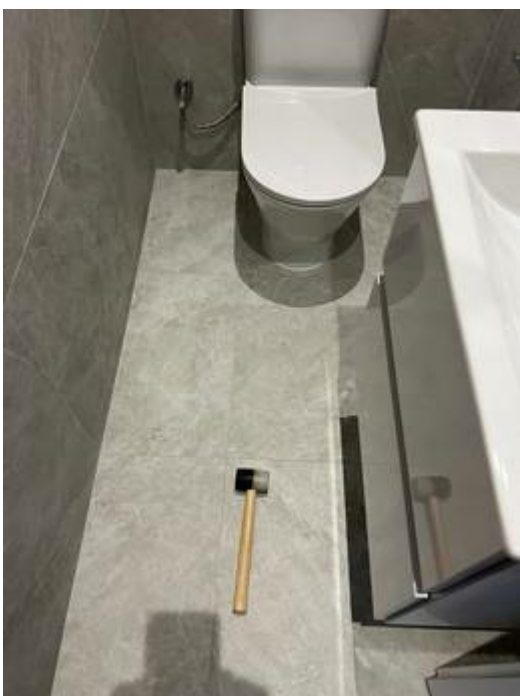
ID:4 Title: Empty sound under the tile

Comments: Guest toilet
Walls are OK

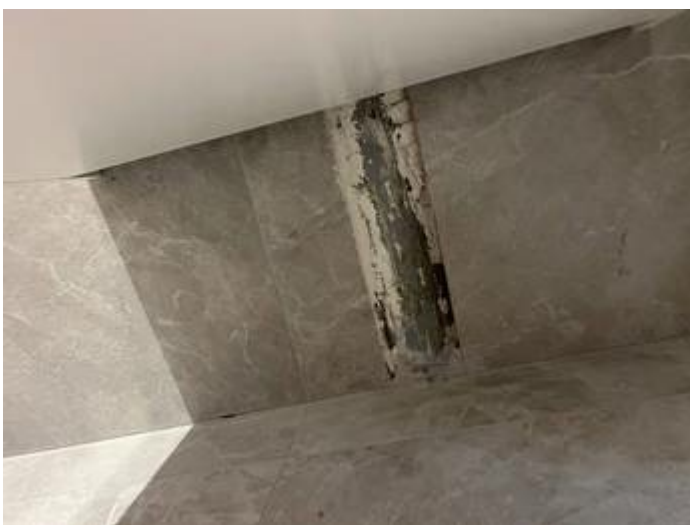
ID:5 Title: Not finished tile work under and behind the washbasin

Comments: Guest toilet

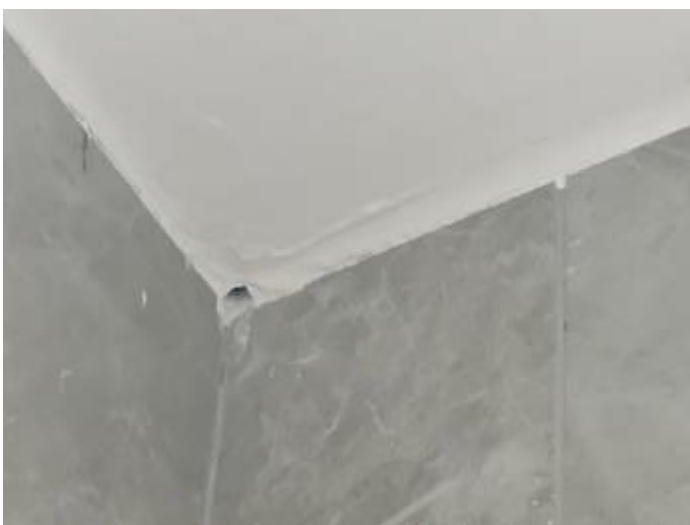
ID:6 Title: Hole in the ceiling

Comments: Guest toilet

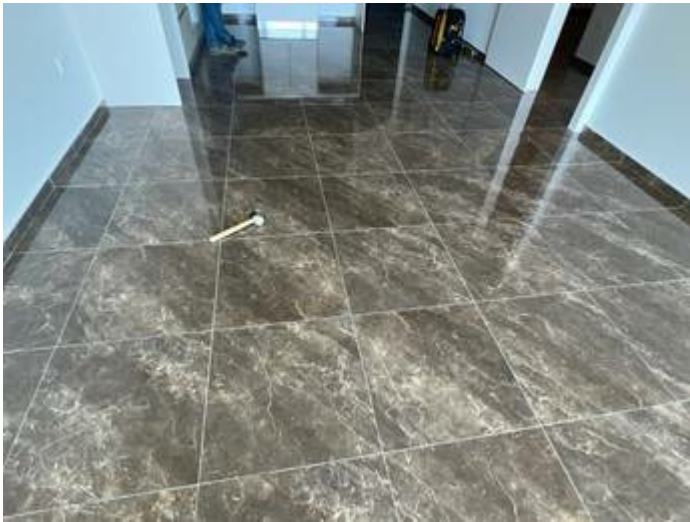
ID:7 **Title: 70 percent tiles have empty sound**

Comments: All flat (possible crack in case of dropping something heavy)

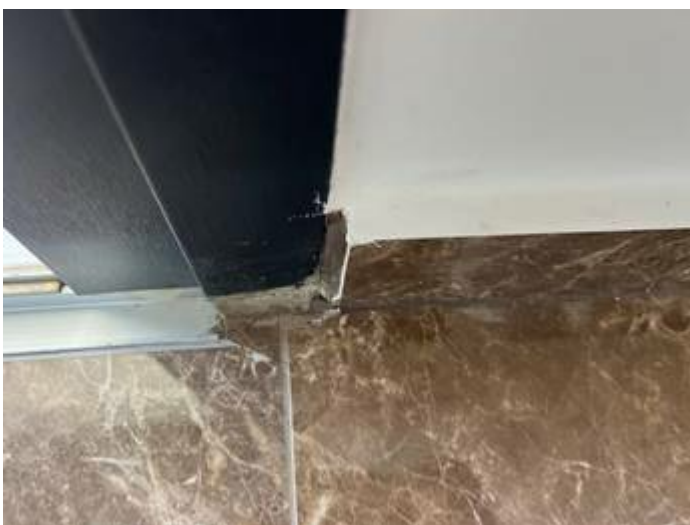
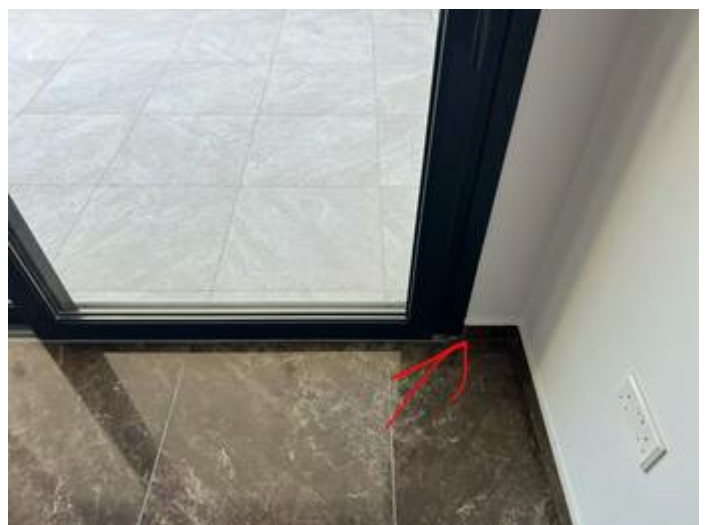
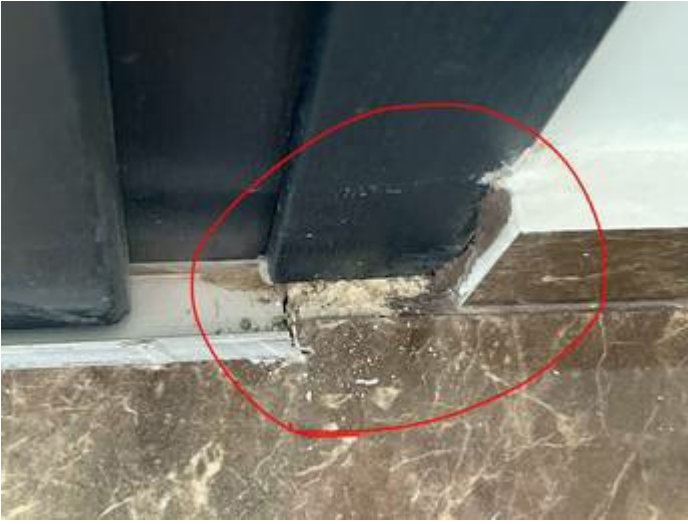
ID:8 Title: Badly done tile measuring

Comments: Main hall

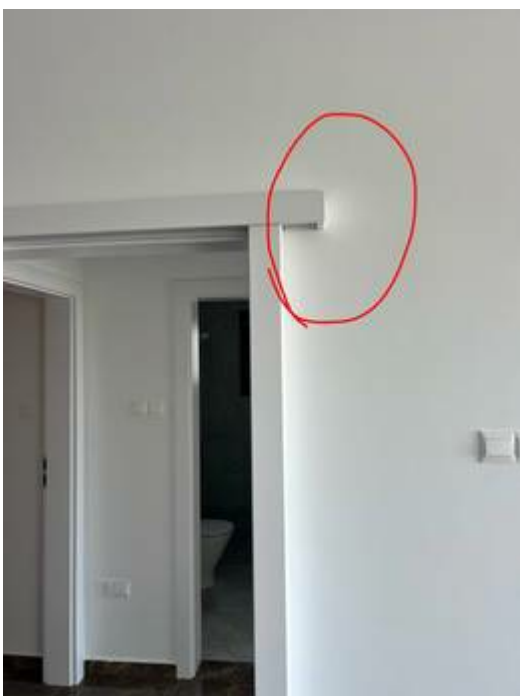
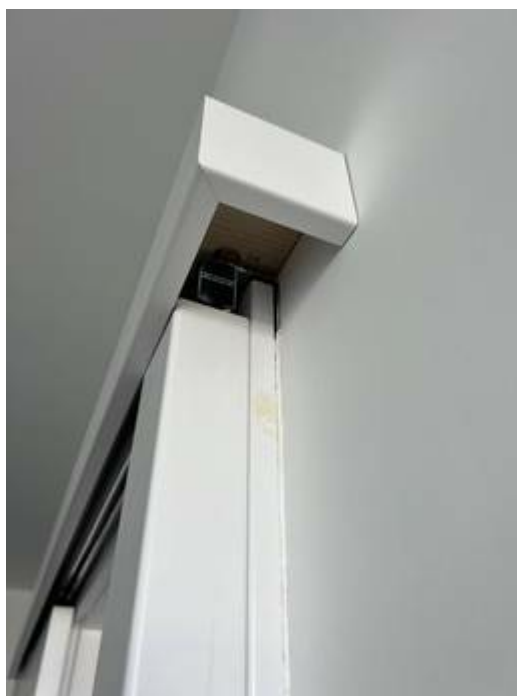
ID:9 Title: Not closed hole or way big wooden cover

Comments: Main hall

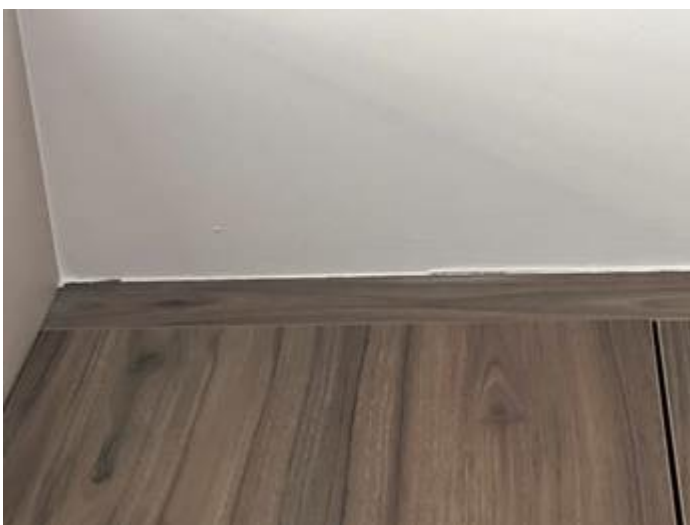
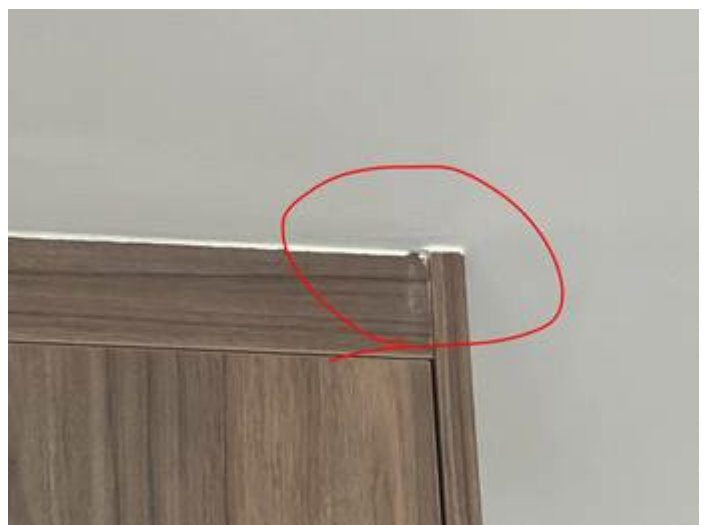
ID:10 Title: Badly done paintwork

Comments: Kitchen

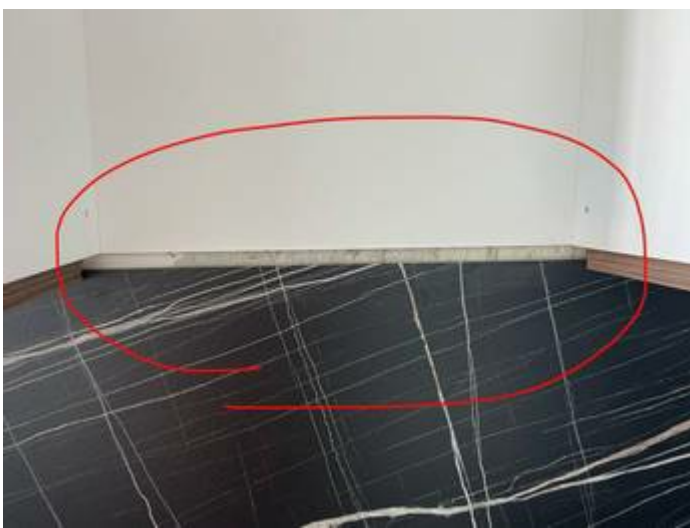
ID:11 Title: Missing decorative skirting

Comments: Kitchen hood

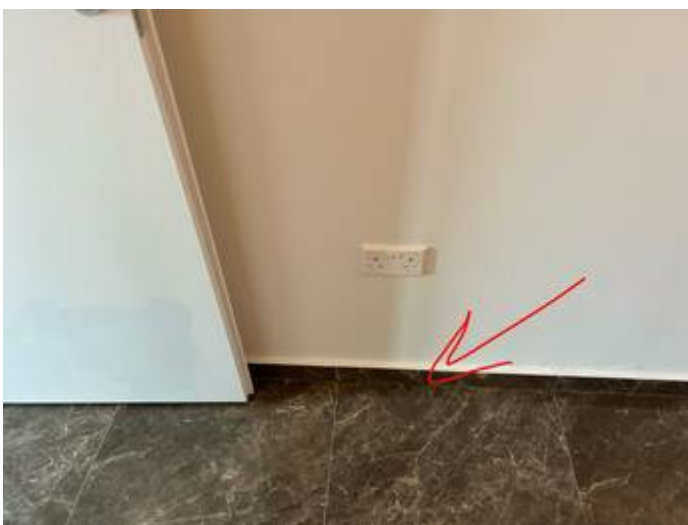
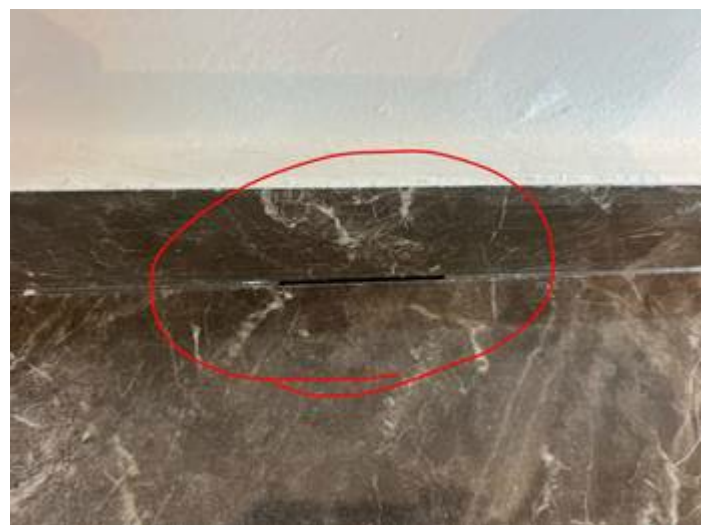
ID:12 Title: Missing grouting

Comments: Bedroom 1

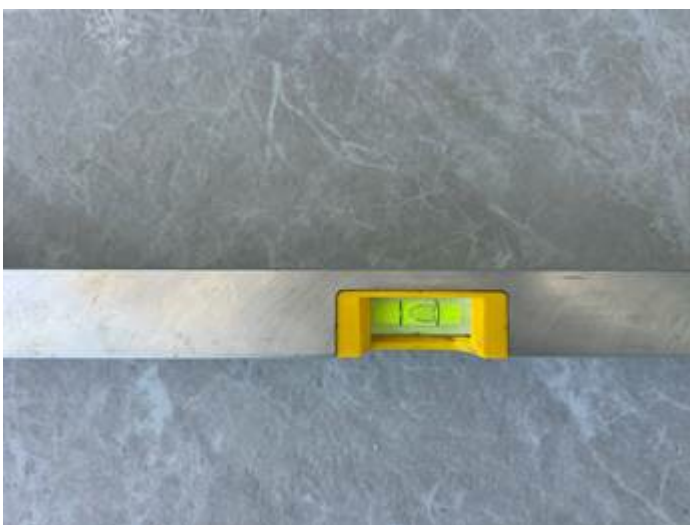
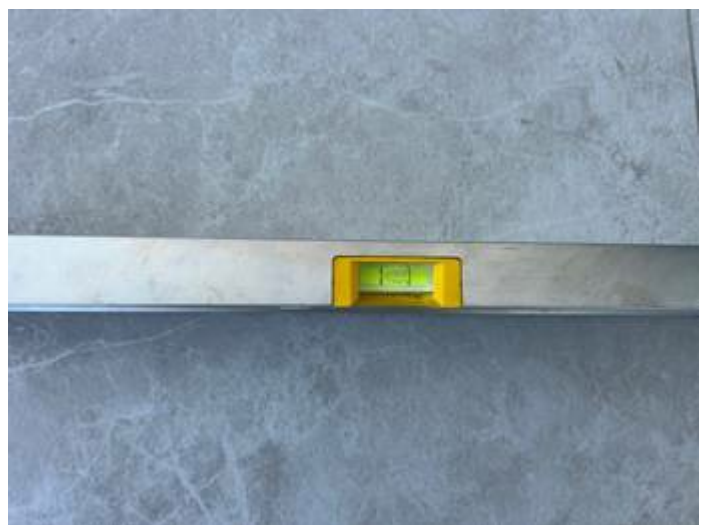
ID:13 Title: Floor levelled checked

Comments: Ok

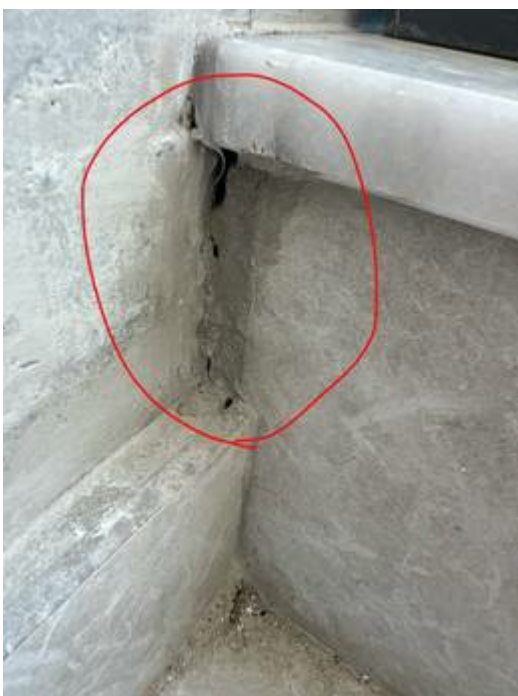
Title: Holes in the joints

Comments: Veranda.

Instructions: Fix with any polymeric concrete repairing material (f.a. - BS18)

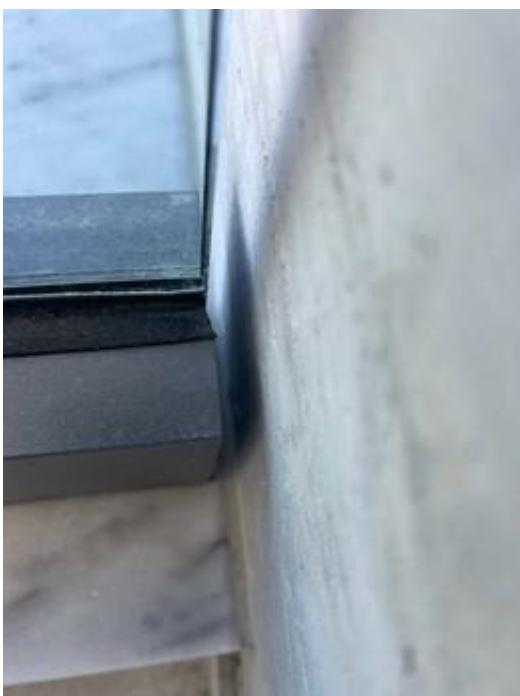
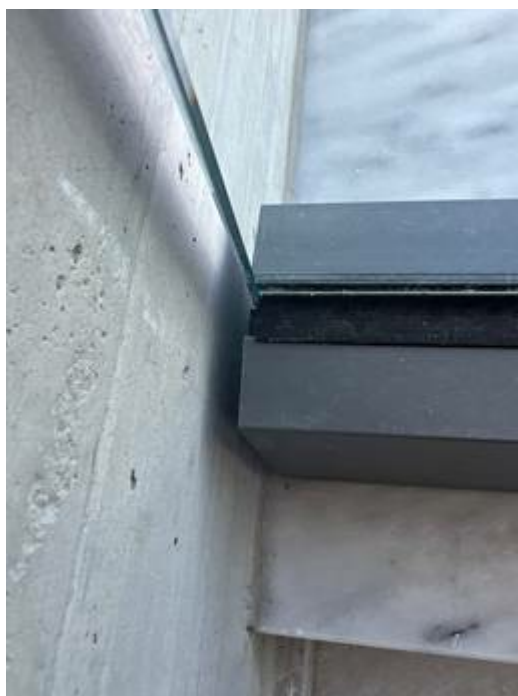
ID:15 Title: Missing caps at the aluminium profile

Comments: Veranda
